# Manhole Inspection Summary

Manhole # S13QQ1026MH

Insp Date: 11/1/06 2:18 PM

**Location** Address: **4914 POE AVE**

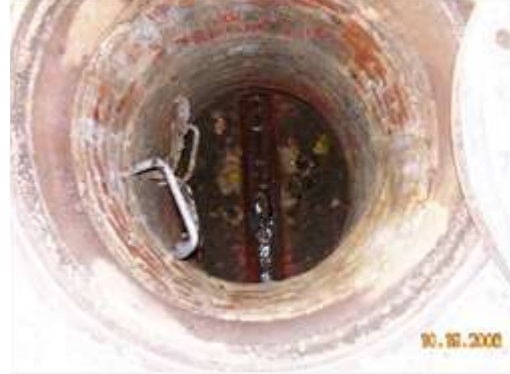
Top View

Bench debris.

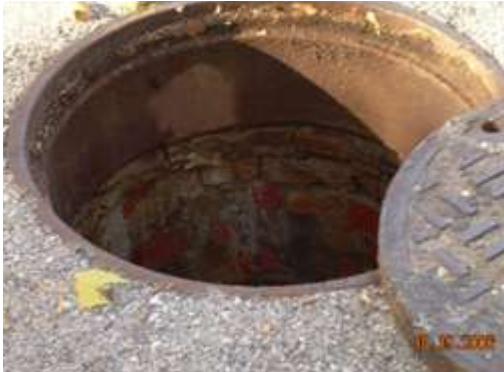
Defect

Frame leaks. Adjustment deterioration, loose brick, and infiltration. Corbel infiltration - other side.

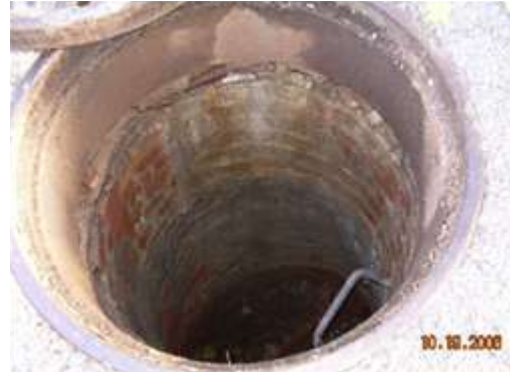
Defect

Frame leaks. Adjustment deterioration and infiltration. Corbel and Barrel infiltration.

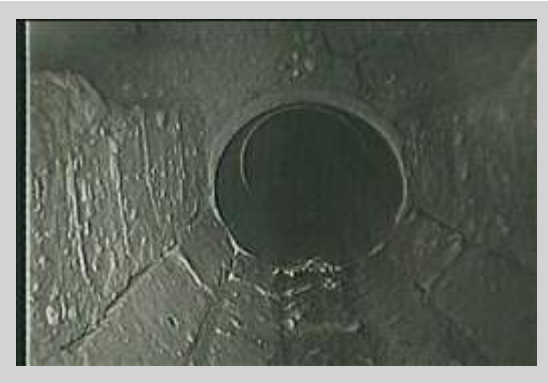
### 8 in. Circular Gravity Sewer Pipe Out @ 12 O'Clock

Channel deterioration.

Infiltration: **None** Pipe Seal Cond: **Cracked**

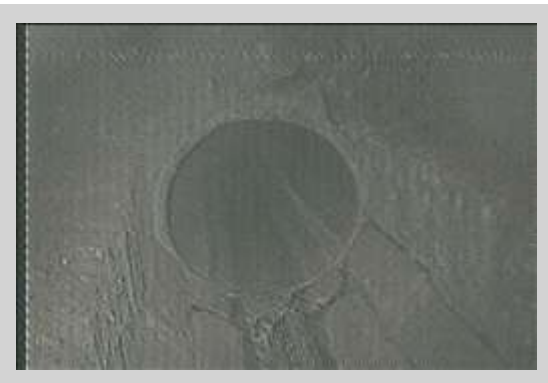
### 8 in. Circular Gravity Sewer Pipe In @ 6 O'Clock

Channel deterioration.

Infiltration: **None** Pipe Seal Cond: **Cracked**
